# Manhole Inspection Summary

Manhole # S330\_\_010MH

Insp Date: **2/12/09 11:22 AM**

**Location** Address: **136 HUGHES ST**

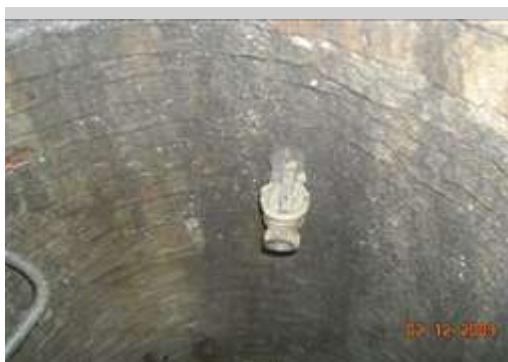
Defect 4

PIPE INTRUSION THROUGH CORBEL  
@ 6 OCLOCK

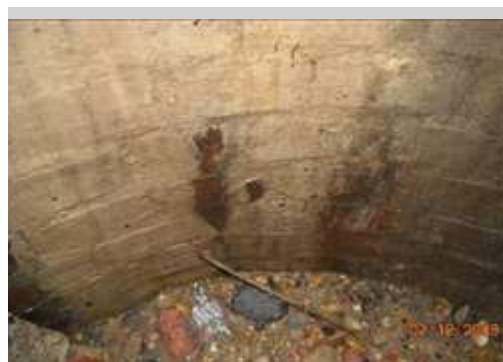
Defect 3

☒ **Wall**

INFILTRATION @ BARREL WALL  
(several places)

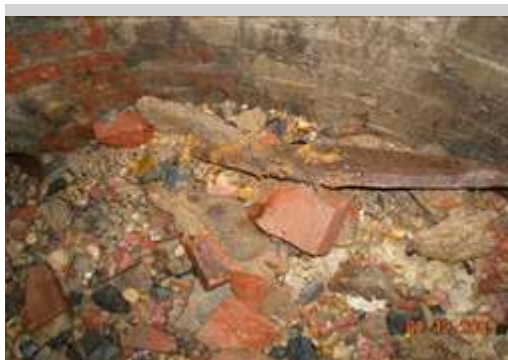
Defect 2

☒ **Debris**

DEBRIS IN TERMINAL CHANNEL

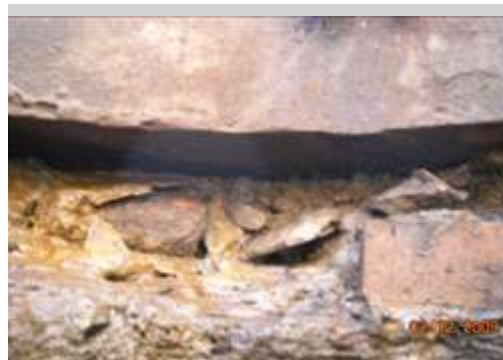
Defect 1

☒ **Deteriorated**

☒ **Joint**

DETERIORATED CHIMNEY &  
INFILTRATION

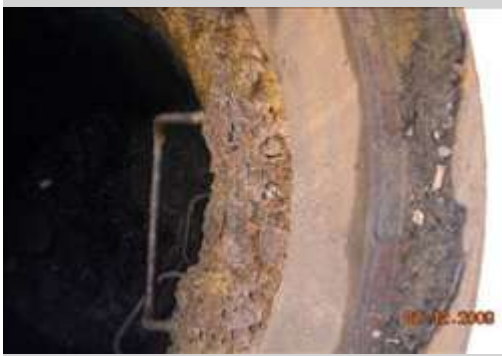
DEfect

Offset: **2** (in.)

☒ **Corroded**

CORRODED STEPS, FRAME OFFSET

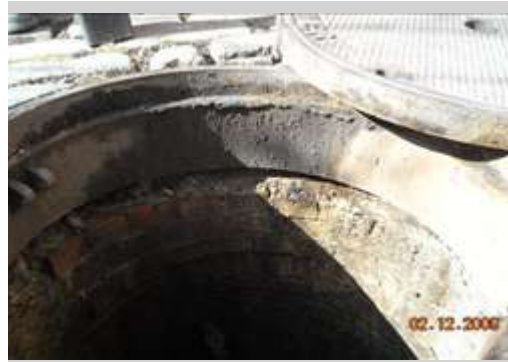
Subject To Ponding: **Sheeting**

INFLOW EVIDENCE FROM SHEETING

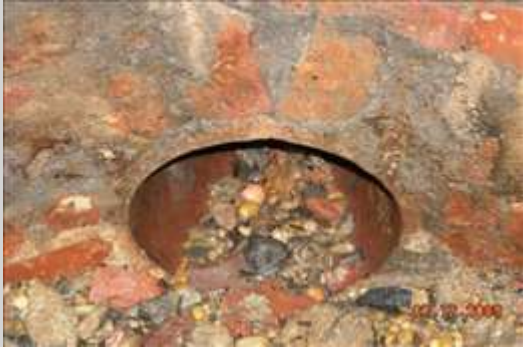
12 O'Clock Outflow

8 in. Circular Gravity Sewer  
Pipe Out @ 12 O'Clock

Deposits: ☐ None ☒ **Mud** ☐ Sludge ☐ Debris ☐ Grease

Silt Depth: **1** (in.) Deposits Extent: **Light**
